# AVOIDING ENERGY “CREEP” - COMMERCIAL OFFICE

- 245,000 square feet, 18 story office tower
- High efficiency perimeter radiation heating and VAV compartment unit cooling

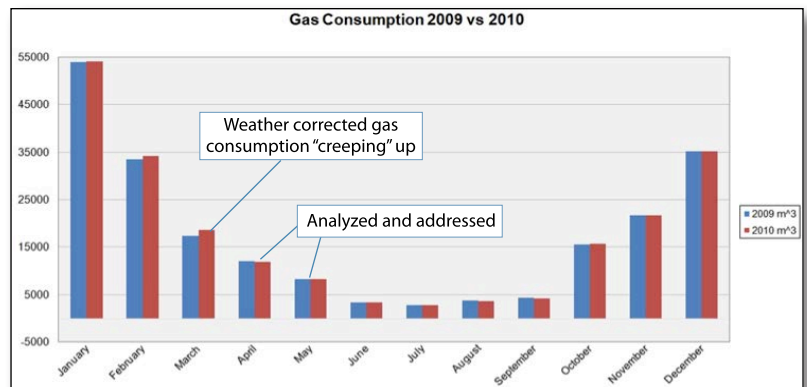
## IDENTIFYING GAS CONSUMPTION “CREEP”

A 245,000 square foot office tower in downtown Toronto began showing signs of increased natural gas consumption. Historically the consumption of natural gas in this building tracked normally in accordance with outdoor air temperatures. Towards the end of the 2010 heating season gas consumption began tracking approximately 7% higher than in prior years.

The cause of the excess gas consumption was resolved by rebuilding the actuator in the 6-inch, 3-way heating valve serving the perimeter radiation loop. Repairs were carried out immediately and excess gas consumption was eliminated within a matter of a few weeks. Had this not been recognized and resolved promptly the excess consumption would likely have been assumed to be weather related and not addressed.
